INDOOR AIR QUALITY ASSESSMENT

**Rockland Memorial Library
20 Belmont Street
Rockland, MA 02370**

Prepared by:
Massachusetts Department of Public Health
Center for Environmental Health
Bureau of Environmental Health Assessment
Emergency Response/Indoor Air Quality Program
August 2004

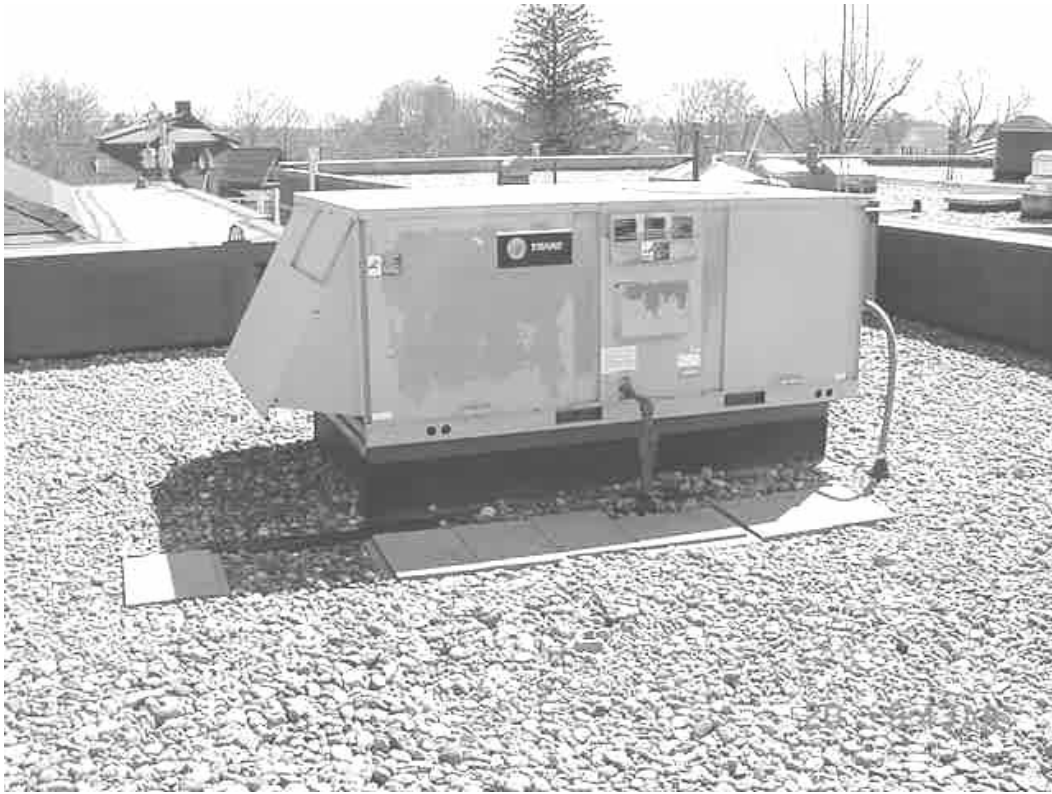
Picture 1

It can be seen from Table 1 that carbon dioxide levels were below 800 parts per million (ppm) in all areas surveyed, indicating adequate air exchange. A heating, ventilating and air conditioning (HVAC) system, which consists of two rooftop air handling units (AHUs) (Pictures 1 and 2), provides ventilation through ducted wall or ceiling vents (Picture 3). Air is returned to the AHUs by wall and/or ceiling-mounted grilles via ductwork. This system was operating intermittently throughout the building on the day of the assessment. Thermostats that control the HVAC system have fan settings of “on” and “automatic”. Thermostats set to the “automatic” setting were observed during the assessment (Picture 4). The automatic setting on the thermostat activates the HVAC system at a preset temperature. Once the preset temperature is reached, the HVAC system is deactivated. Therefore, no mechanical ventilation is provided until the thermostat re-activates the system.

Rooftop AHU (1 of 2)

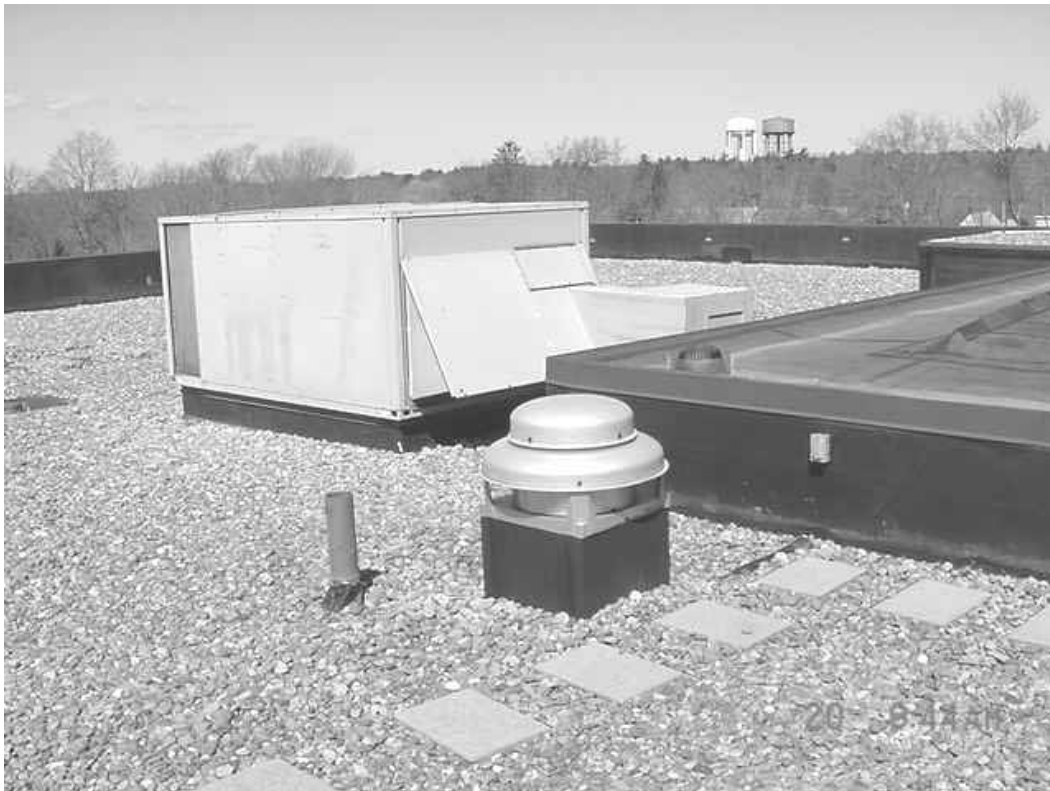
Picture 2

Rooftop AHU (2 of 2)

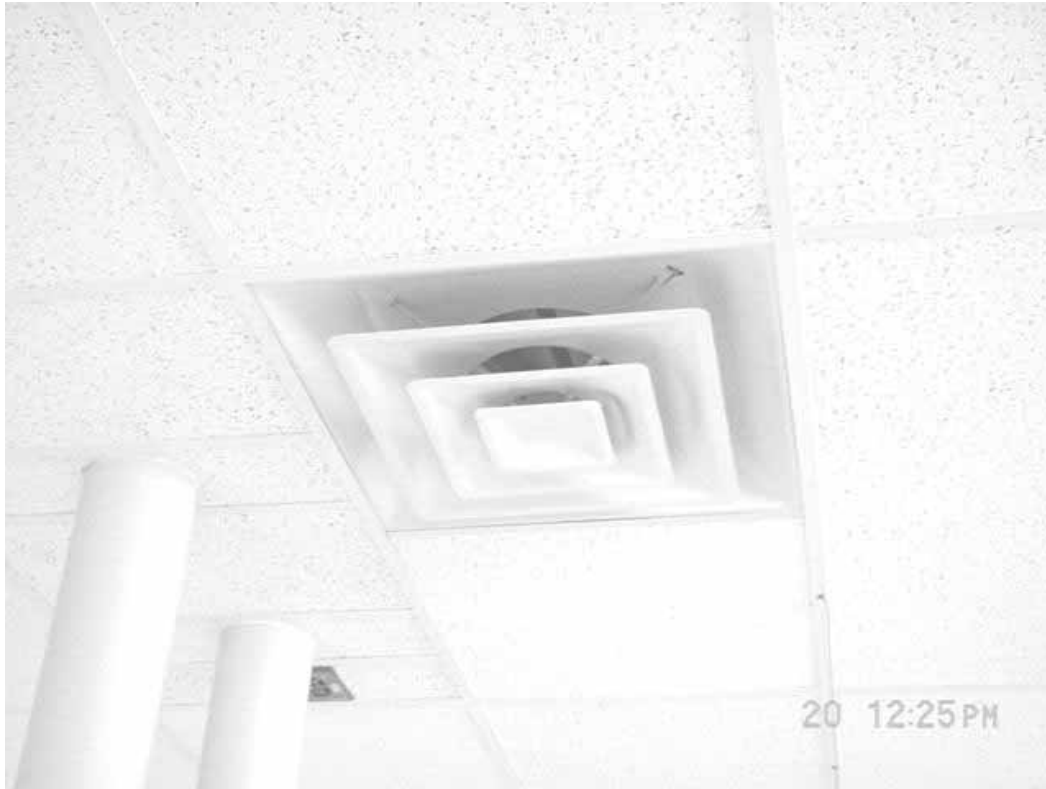
Picture 3

Ceiling-Mounted Air Diffuser

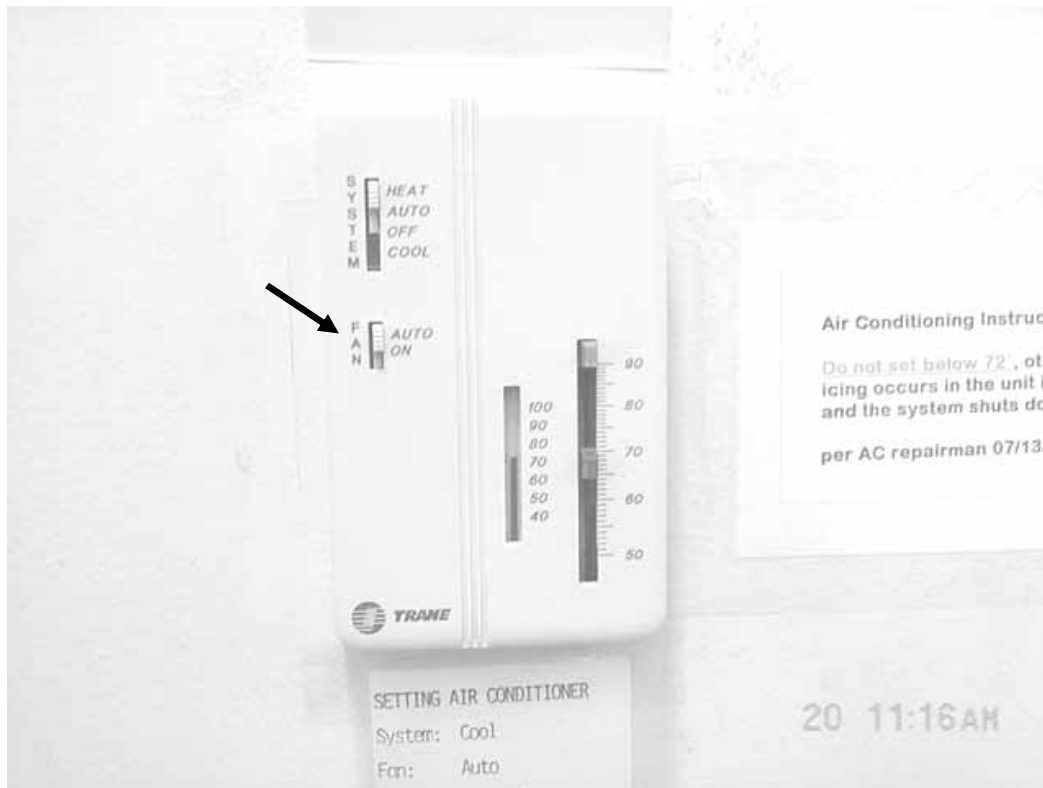
Picture 4

Thermostat, Note Fan Setting in “Auto” Position

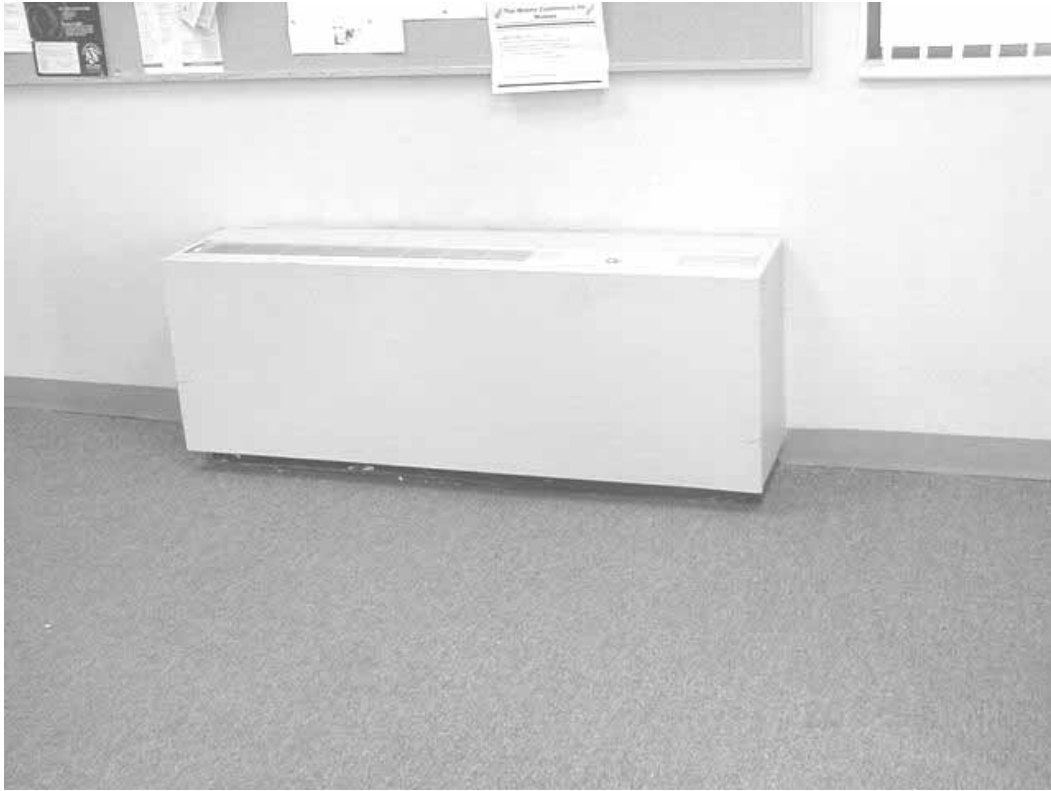
Picture 5

Fan coil units (FCUs) located along the base of walls (Picture 5) provide supplemental heating or cooling as needed. FCUs do not have the capability of

Typical Fan Coil Unit (FCU)

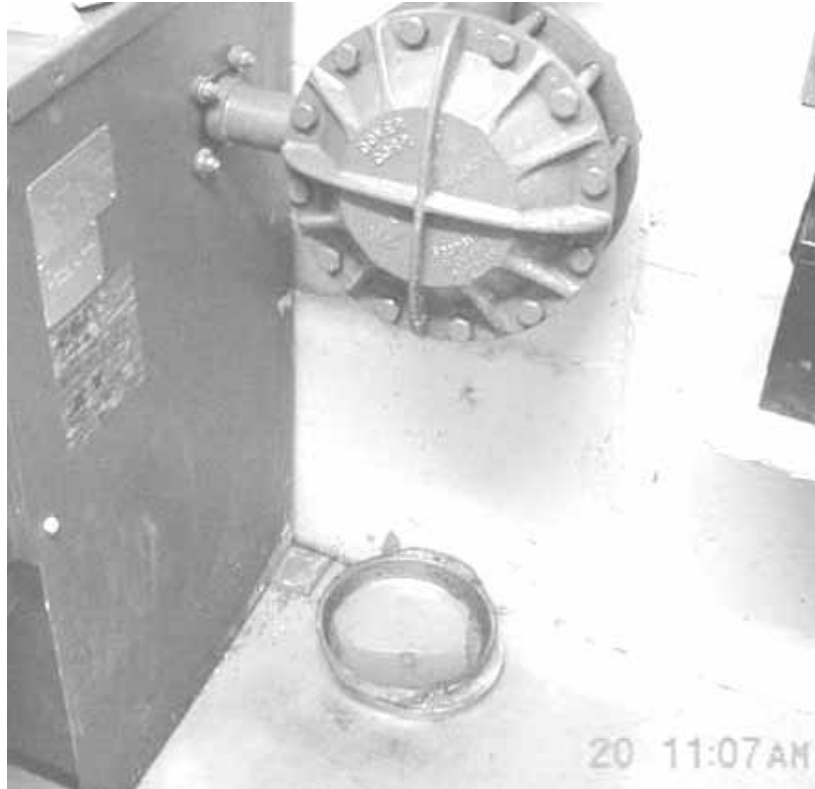
Picture 6

Although no signs of water damage, microbial growth or elevated moisture content were observed, BEHA staff detected a moderately musty odor during the assessment. The most likely source of odors was traced to a hydraulic leak found in the elevator mechanical room, which is near the main hallway. Ms. Brown reported that the equipment has leaked for some time, as evidenced by the soiling of the concrete floor beneath the leak observed during the assessment. To prevent pooling of hydraulic fluid on the floor, library staff placed an aluminum pan beneath the leak (Picture 6). Hydraulic fluids contain VOCs, which can be irritating to the eyes, nose and throat. Over time the organic components can break down producing pungent mold-like odors.

Aluminum Drain Pan for Hydraulic Fluid Leak, Note Soiled Concrete Floor around Pan

At the time of the assessment, BEHA staff recommended: 1) hydraulic fluid be emptied from the pan periodically to prevent breakdown of organic components; 2) soiled areas on the concrete floor be scrubbed with detergent as an attempt to remove residue and 3) the elevator service company be contacted to assess and repair the leak. In a subsequent conversation, Ms. Brown reported that the elevator service company inspected the mechanical room. According to Ms. Brown, due to the cost of replacement parts, funds are not currently available for repairs. Ms. Brown also indicated that the drain pan is emptied on a regular basis; and odors have been significantly reduced.

1. Continue to empty drain pan in elevator mechanical room to help prevent odor migration into occupied areas until repairs can be made to the elevator hydraulic system. Clean soiled areas on floor with detergent and rinse with soap and water.
2. Operate ventilation systems throughout the building continuously during periods of occupancy, independent of thermostat control, to maximize air exchange. Set thermostats to the fan “on” setting to provide continuous air exchange.
3. Operate FCUs to facilitate airflow.
4. Change filters in all air handling equipment as per the manufacturer’s instructions or more frequently if needed. Clean interiors of FCUs during regular filter changes.
5. Consult a ventilation engineer concerning re-balancing of the ventilation systems. Ventilation industrial standards recommend that mechanical ventilation systems be balanced every five years (SMACNA, 1994).

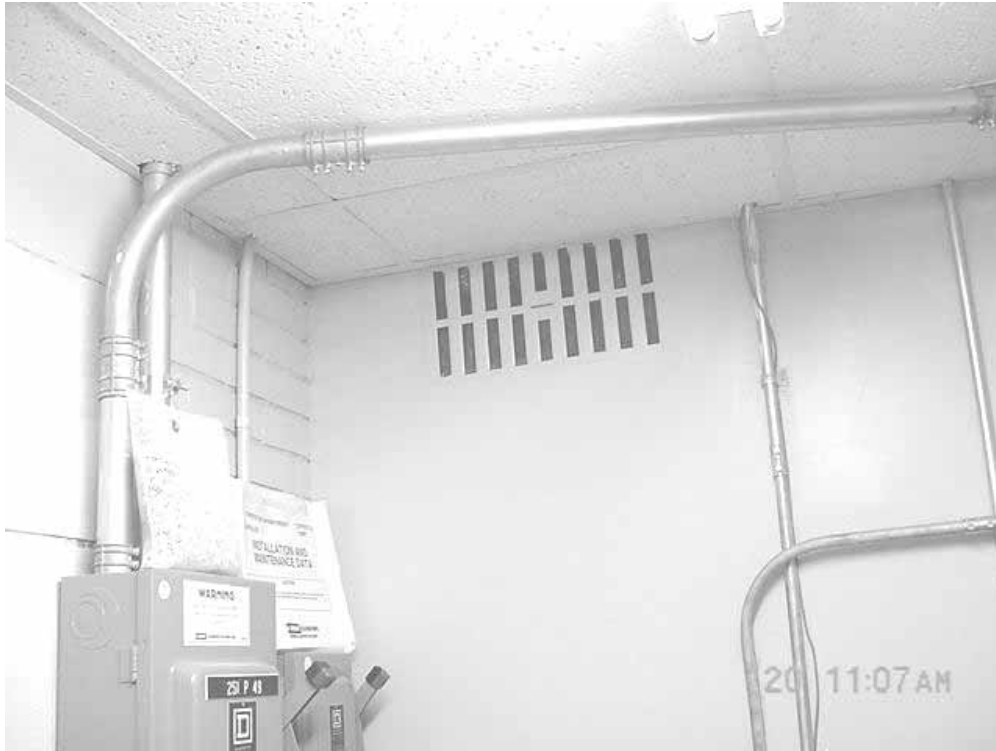
Picture 7

In addition, movement of the elevator in the shaft is similar to the actions of a piston, where pressurization and depressurization of air occurs. Pressure changes to air in the elevator shaft and adjacent mechanical room can force odors to other areas of the building (Pictures 7 and 8). In an effort to determine whether measurable levels of VOCs were present in the building, BEHA staff conducted air monitoring for TVOCs. Outdoor air samples were taken for comparison. Outdoor TVOC concentrations were ND. Indoor TVOC measurements throughout the building were also ND (Table 1). Please note, TVOC air measurements are only reflective of the indoor air concentrations present at the time of sampling.

Passive Pressure Relief Vent in Common Wall between the Elevator Shaft and Mechanical Room

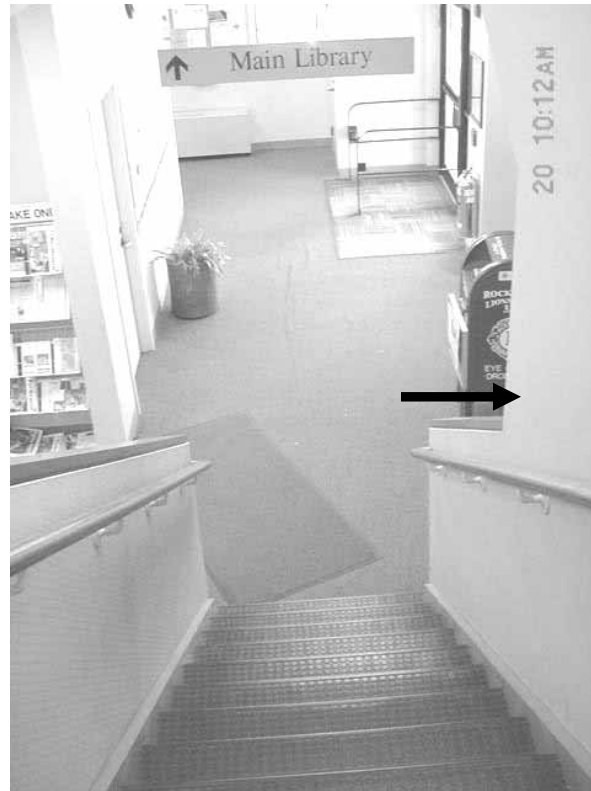
Picture 8

View of Main Hallway from Top of Stairwell Where Odors were Reported/Detected, Arrow Indicates Location of Elevator Mechanical Room Where Hydraulic Leak was Found

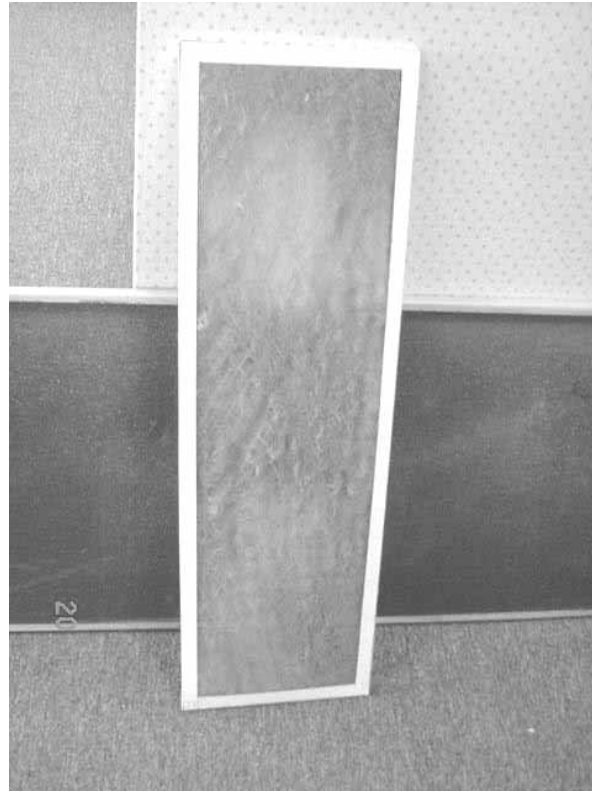
Picture 9

Several other conditions that can affect indoor air quality were noted during the assessment. The FCUs are equipped with filters that provide minimum filtration to strain particulates from airflow. Ms. Brown reported that filters are changed once per year. BEHA staff examined FCU filters in the main hallway. The filters were observed to have accumulated dust and debris (Pictures 9 and 10). A number of FCUs also had dirt, dust and debris accumulated within the air handling chambers. These conditions may be attributed to non-continuous equipment operation, which allows airborne particulates to settle within the units. In order to prevent equipment from serving as a source of aerosolized particulates, the air handling sections of FCUs should be cleaned regularly (e.g., during regular filter changes). An increase in filter changes per year should be considered.

FCU Filter in Main Hallway

In order to decrease aerosolized particulates, disposable filters with an increased dust spot efficiency can be installed. The dust spot efficiency is the ability of a filter to remove particulates of a certain diameter from air passing through the filter. Filters that have been determined by ASHRAE to meet its standard for a dust spot efficiency of a

minimum of 40 percent (Minimum Efficiency Reporting Value equal to 9) would be sufficient to reduce many airborne particulates (Thornburg, 2000; MEHRC, 1997; ASHRAE, 1992). Note, increasing filtration can reduce airflow, a condition known as pressure drop. Reduced efficiency of the FCU is due to increased resistance. Prior to any increase of filtration, a ventilation engineer should be consulted to determine whether FCUs can maintain function with more efficient filters.

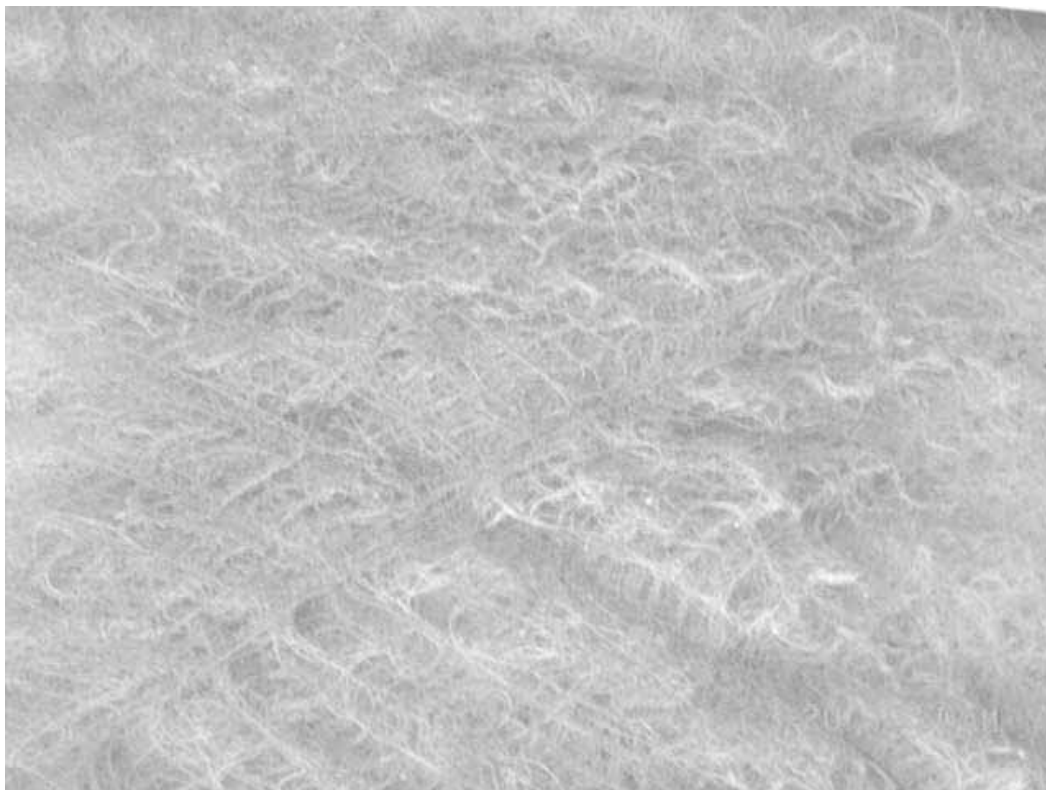
Picture 10

Close-Up of Filter in Picture 9
